Winchelsea Vaults

On 1st August, Ghost, Skyframe, Shades and Jo went off on an expedition to explore the underground vaults below the remarkably strange and peculiar town of Winchelsea.

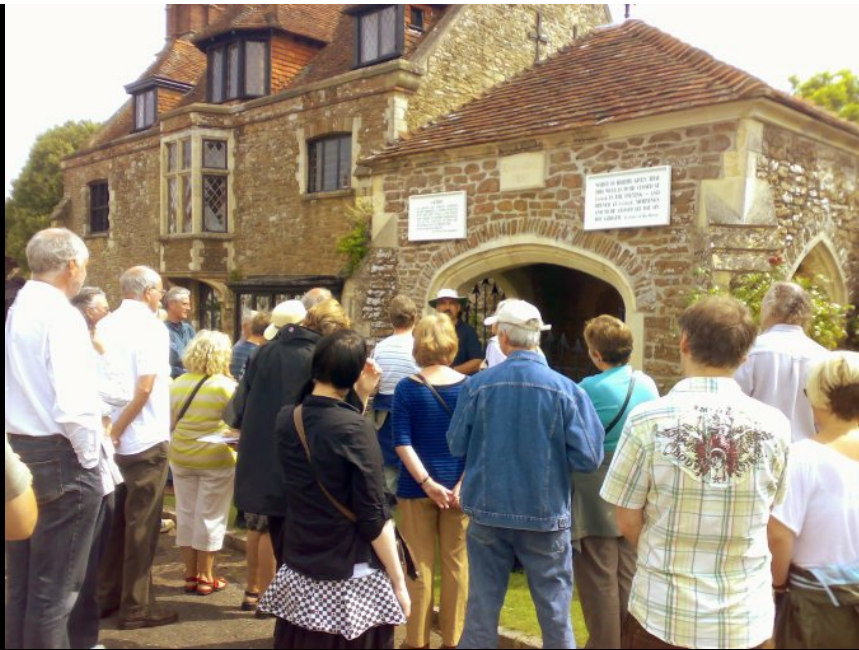
ABOVE & BELOW: This building was originally the town's armoury and (like most of the buildings in this insane place) is totally all over the place. The facade looks really old but was built in the turn of the century, yet the main bulk of the building beneath the facade is actually very old indeed, dating from around 1300. The smaller building on the right is the town's well. The fact that the whole town appeared to drink very little other than wine gives some indication as to the quality of the water.

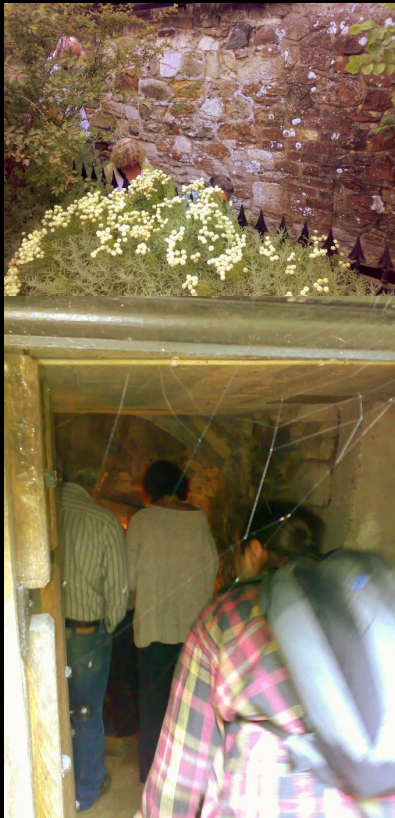
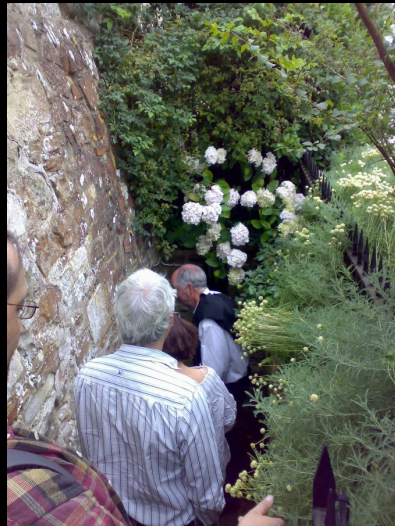
CLOCKWISE FROM TOP LEFT: This is the entrance to the first vault: blink and you'd miss it! All of the vaults are at the front of the property's plot and their entrances were originally direct from the street rather than from within the boundaries of the buildings above them.

BELOW: The vaults abutting the street are all entered down straightflights of steps, typically between 4ft and 5ft 2 ins in width. In at least 19 of the surviving vaults, the stairs to the street are the only way in.

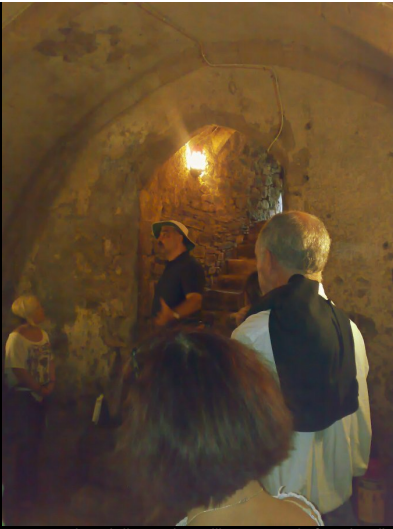
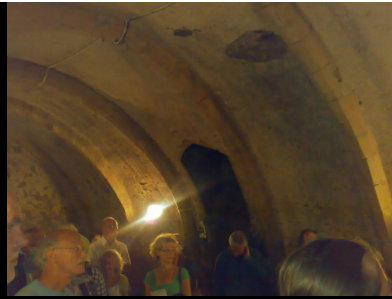
TOP- LEFT & RIGHT: The walls of the vaults are built up from slabs of Tilgate Stone which is laid in rough courses. The faced surface is just a rough cement render apart from those withing vaults with windows, where the walls were quite highly decorated.

The decorative stonework and ribs on the ceiling are made from locally produced "Cliff End" Sandstone.

Some of the arches are not quite true and look rough: it has been suggested that in some instances, the arches are made from stone salvaged from the original village. The ribs are not entirely load bearing and a lot of vaults have proven to be self-supporting where their ribs have collapsed!

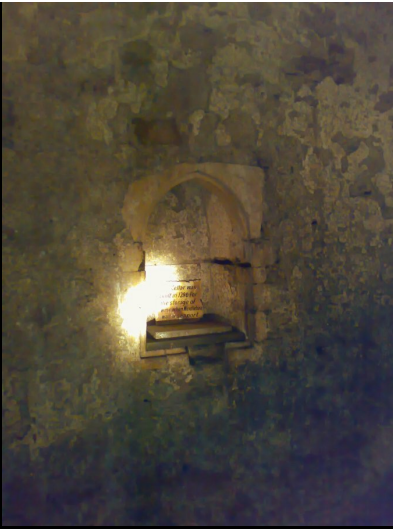
BELOW LEFT: About half of the vaults have a small cupboard (or cupboards) at the back of them called "Aumbries". These were recessed into the wall and would have had doors fitted to them, giving the appearance and functionality of a medieval safe. In some of the vaults, they are positioned in or around the front or rear staircase.

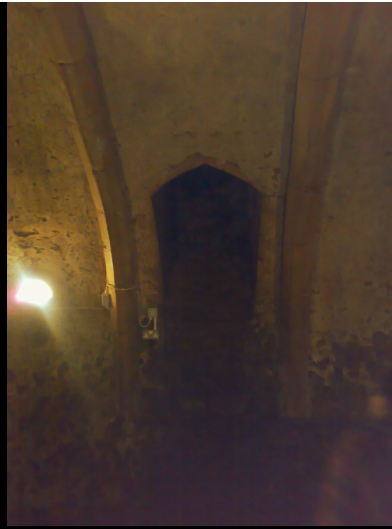
BELOW RIGHT: Sometimes the vaults have odd shafts in the ceilings. Occasionally these could be a kind of "serving hatch" arrangement leading to the room above. There are known instances elsewhere of fireplaces in some larger vaults. The one seen here was possibly for ventilation.

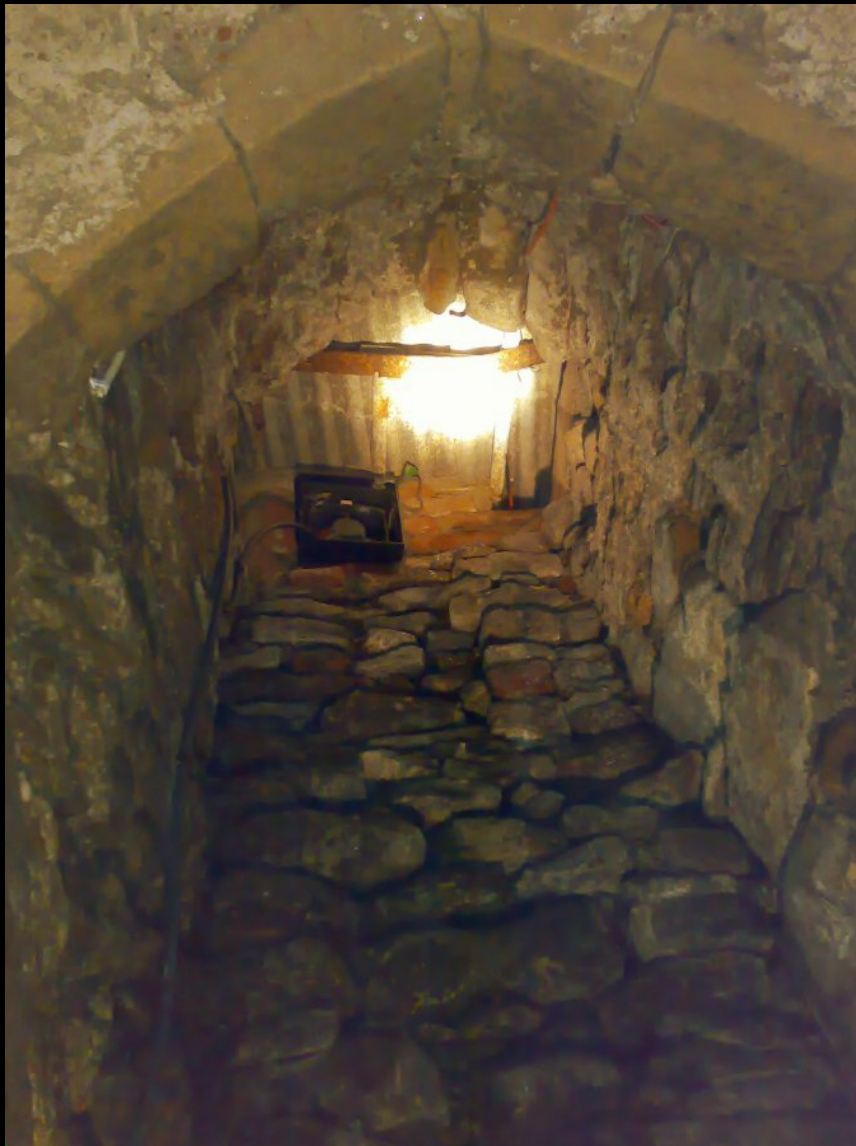
BELOW: Bricked up or removed window / light well: About two thirds of the vaults would have had windows set into the front wall (occasionally a side wall if it was on a corner plot) and they would have had very steep sills as seen in the picture below. A lot of the vaults would have just relied on natural light from the doorway to illuminate them. This was alright when the vault was a single room, but in the case of the 3rd vault we saw, the light quickly faded after the first room and was virtually non-existent by the third room in, which would have made them quite spooky.

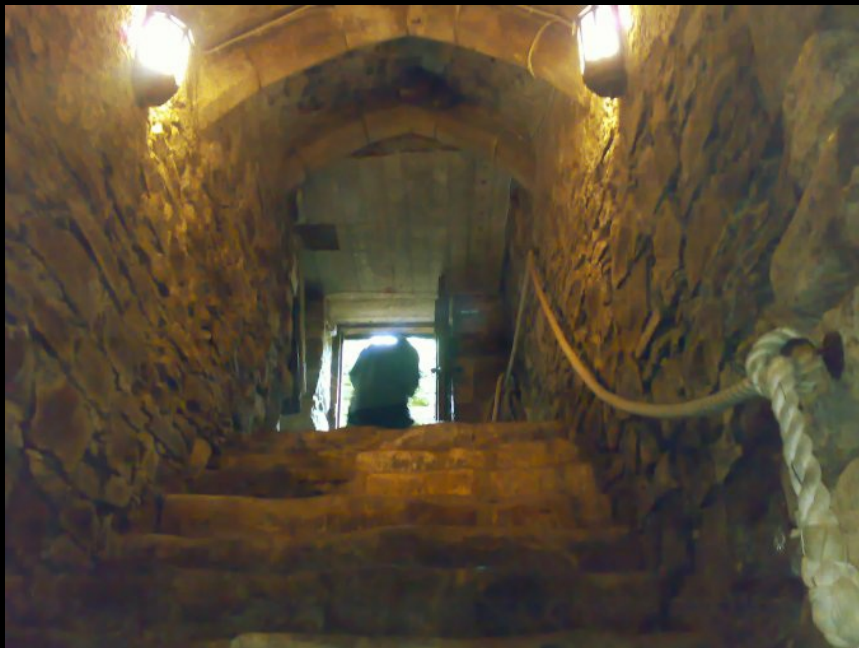
BELOW: The floors of the vaults were usually made of compacted earth or slabs of Tilgate Stone, as in the construction of the walls. In some vaults, the floor has been dug out to the level where the stone is naturally occurent as strata (ie: there already - very lazy!)

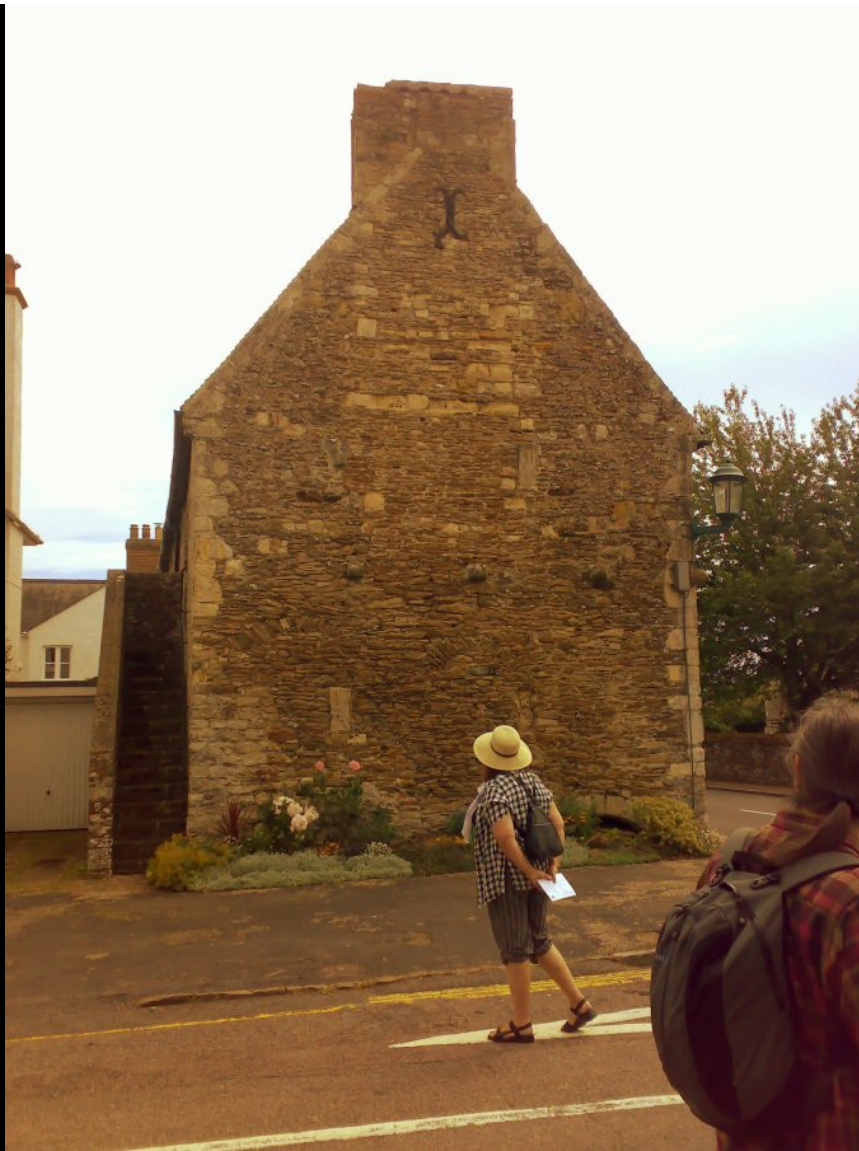
ABOVE: As I've mentioned elsewhere in this part of the website, Winchelsea was a mass of architectural contradictions and this building was no exception. It is a mass of blocked up windows and doorways, all in stone of course. There were so many different types and sizes of stone used, sometimes rendered also, that the place looked like a huge patchwork quilt. As the requirements of the building have changed, the walls are as readable as a notebook. Incredible.

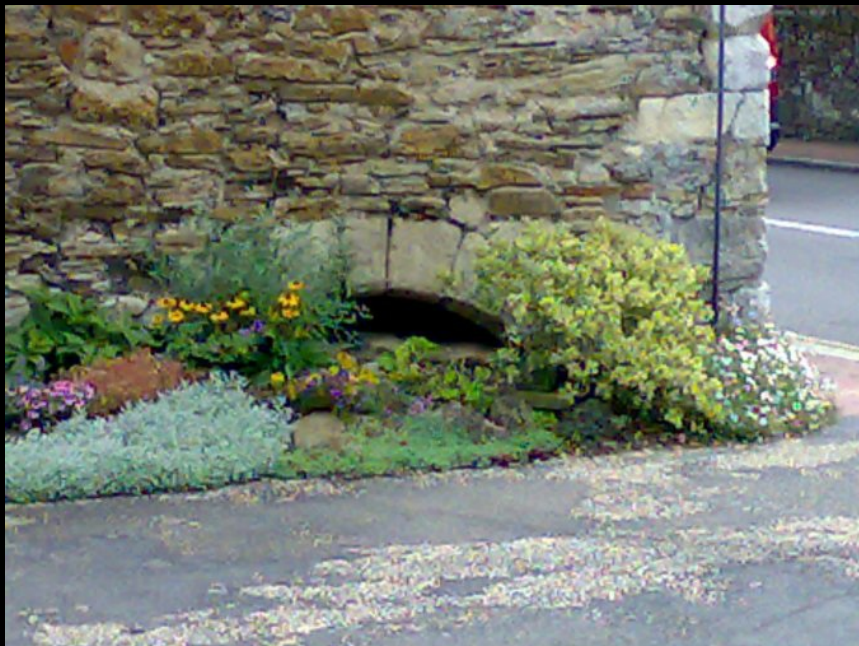
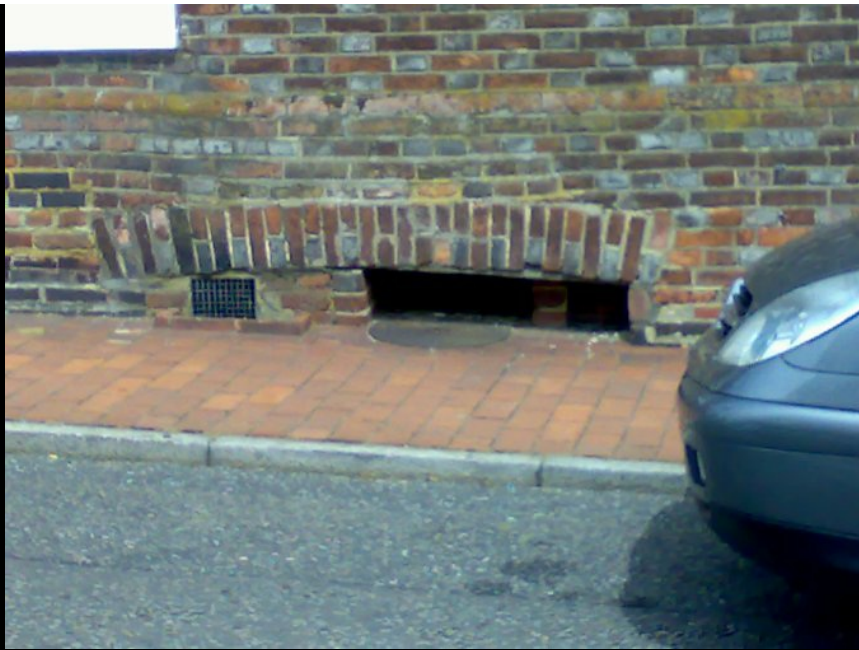
ABOVE & BELOW: Everywhere we looked there was evidence of more vaults, whether unused or intentionally blocked off. The Heads (or tops of the visible entrances) to the vaults appear above street level in the lower facade of the building above it. Suggestions that the street level was a lot lower at the time of construction than it is today can be discounted, as the visible access to the vaults has remained the same.

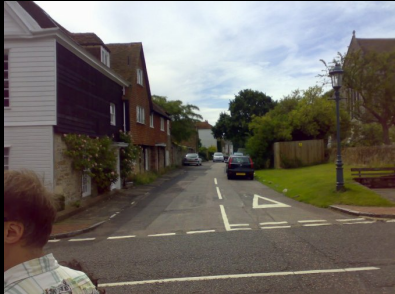
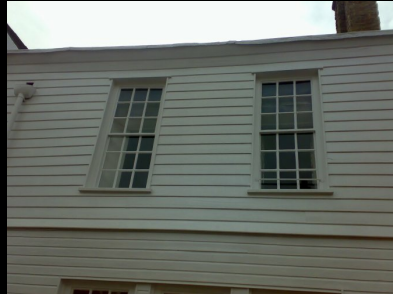
CLOCKWISE FROM TOP LEFT: What's goin' on ear, then? The white house on the corner was very interesting, but we had to look carefully to see why. Have a closer look at the windows: the frontage looks Georgian and a casual passer-by would be easily fooled by this need to keep the property compliant with current architectural fashions. However, the windows gave a fantastic glimpse of what lay beneath the fashionable exterior. The photo below shows things most clearly: there is a large wooden beam crossing the top of the window aperture roughly 2 thirds up its height. This is a clear indication of a far, far older building underneath. It would have been quite interesting to see the view from the inside, to gauge how it looked. Our second vault was just underneath here.

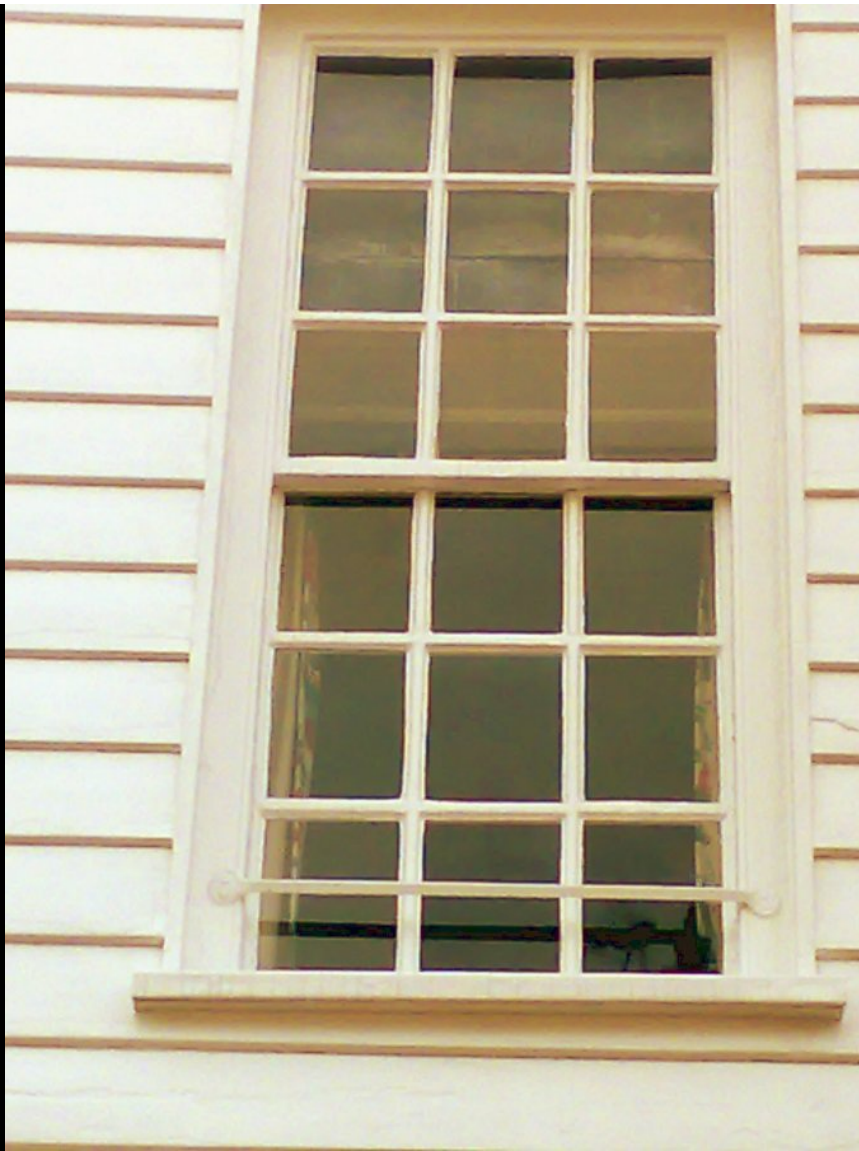
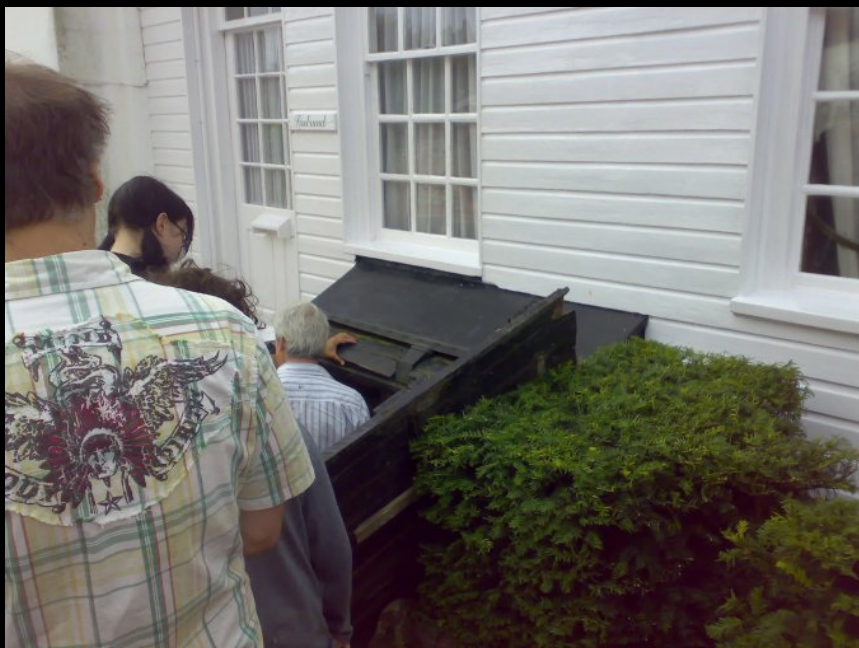
ABOVE & BELOW: This vault was a little more awkward to get into: we had to approach it crabwise from the right, step onto the top step sideways, then walk down the steps diagonally whilst bent almost double. The layout is original and it is thought that smaller barrels and wine casks were the mainstay of the items stored in here.

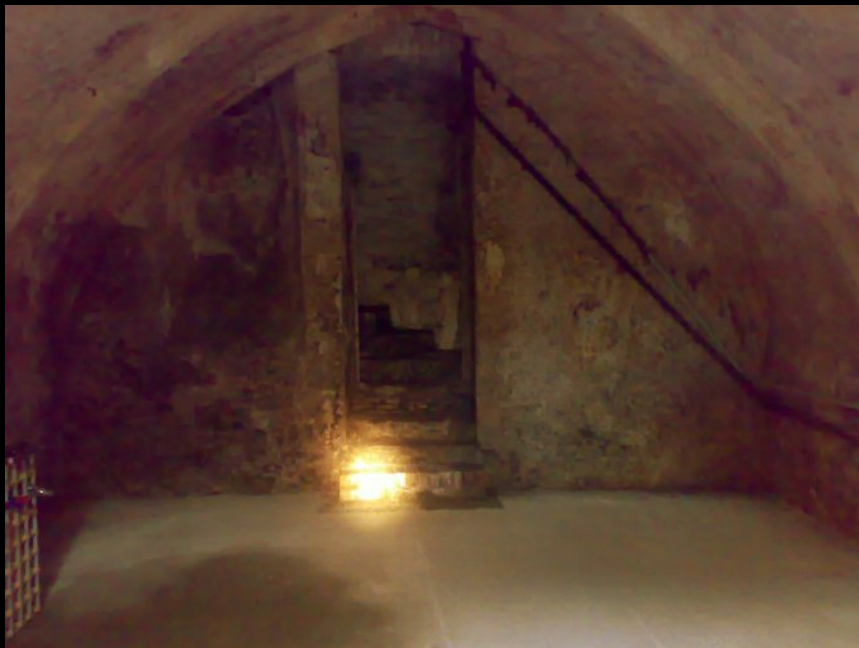
BELOW: Eight of the vaults which survive into the present day have a second smaller staircase leading to the house above. In some instances, the staircase to the rear lead up to a rear courtyard. There are 3 such examples in the town.

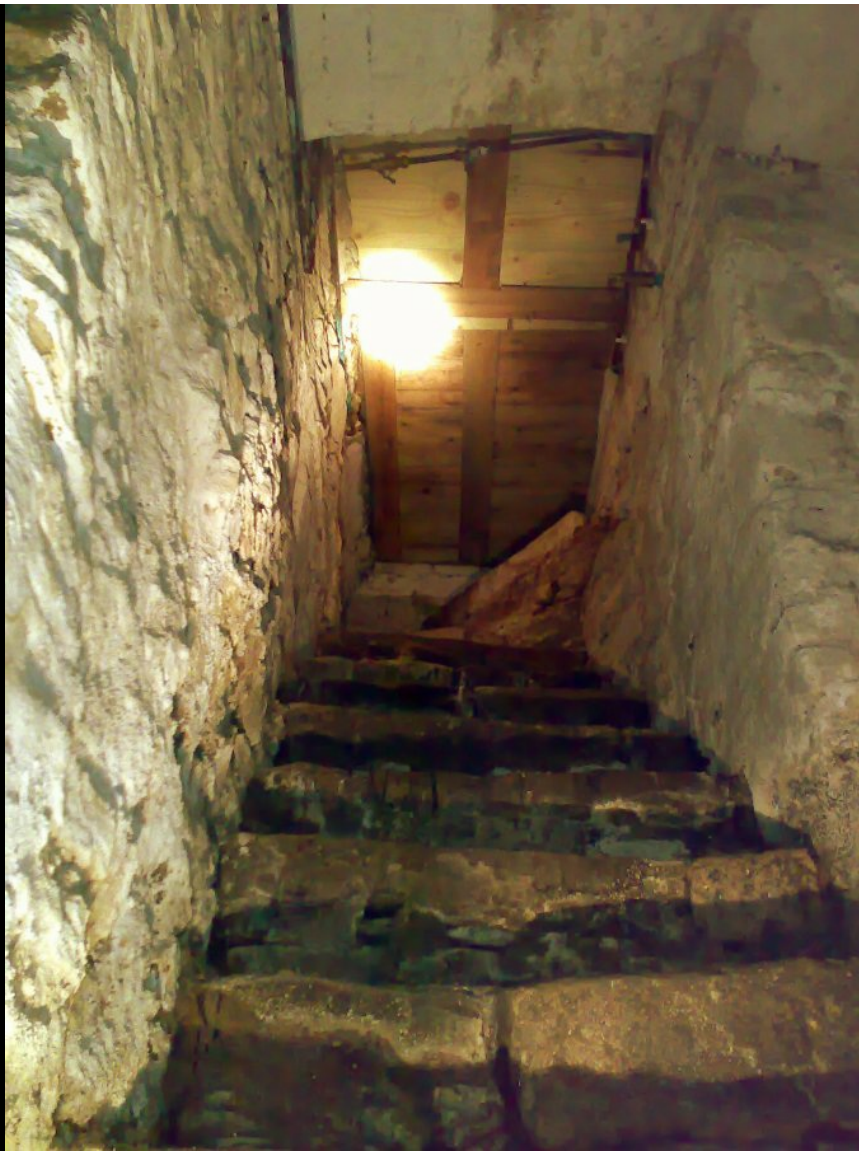
BELOW: Detail shot of the back staircase up to the room above, or possibly the courtyard. In this instant it's been boarded over and probably made into another small room above: a bit of a shame as it would have been an incredible feature to retain.

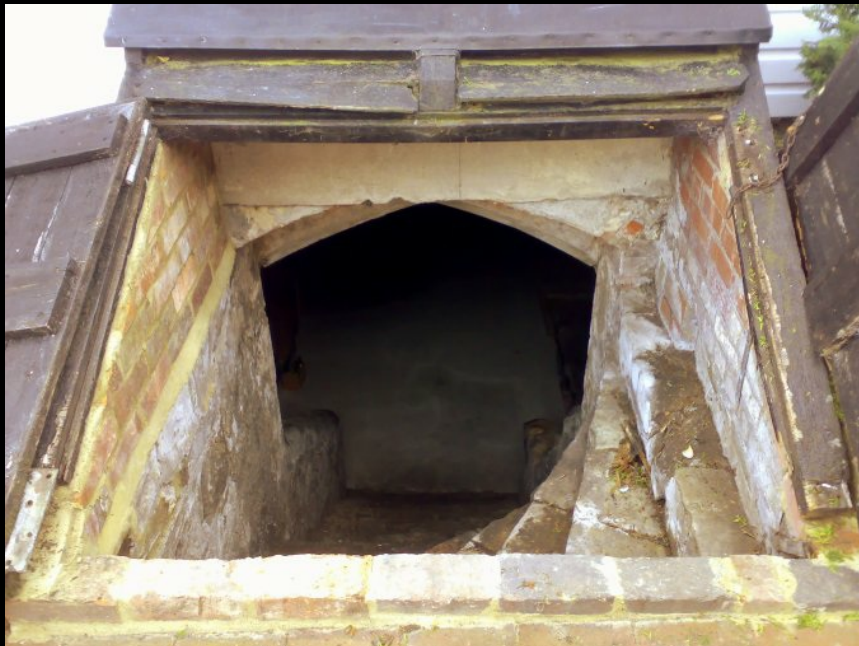
BELOW: In most cases there would have been double wooden doors set into the entrance arch. Originally these would have opened into the vault and would have required quite a lot of room to open fully. This meant that the ground floor of the building above the doorway of the vault would have been raised above the rest of the floor area, resulting in a sort of step along the outer wall of the room. In a lot of cases, the hatches seen at street level in the present day are later additions. It is thought that, originally, there would have been porch-like structures built over the vault entrances to shield them from bad weather.

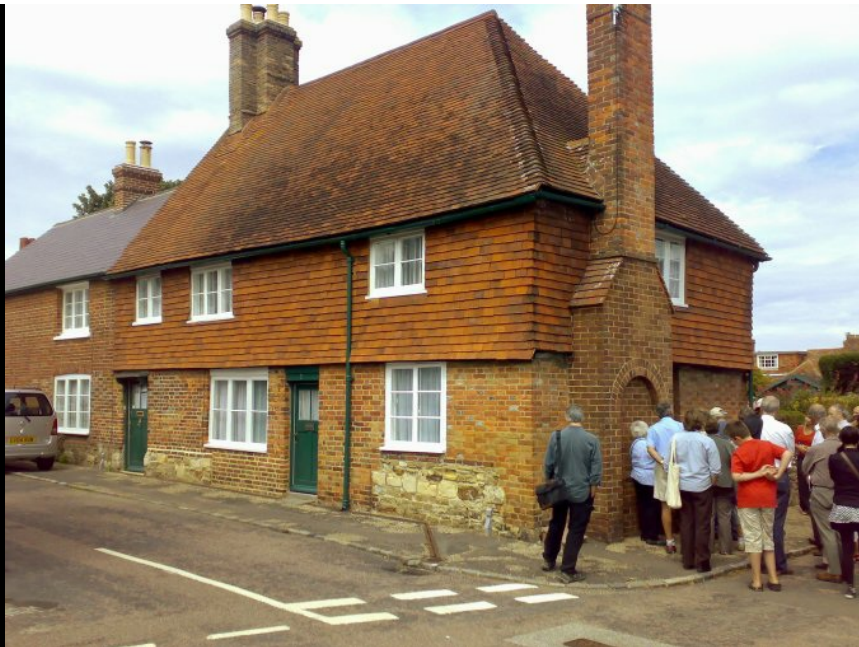
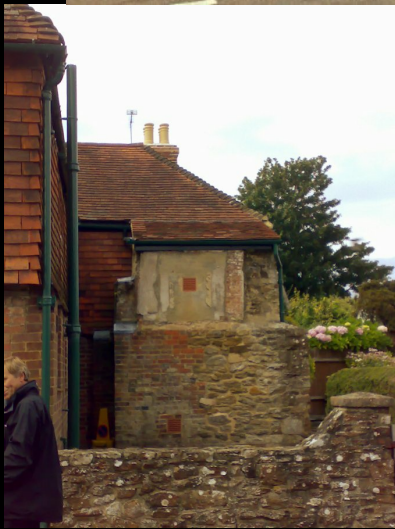
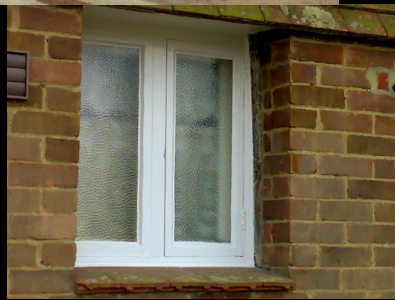
CLOCKWISE FROM LEFT: Another mish mash of architectural features greets us at the house above the third vault. Again, from a distance, this looks like a fairly bog-standard Victorian house, but there are little glimpses of far earlier stonework and timber framework. Note the wooden windowframes just inside the brick aperture above.

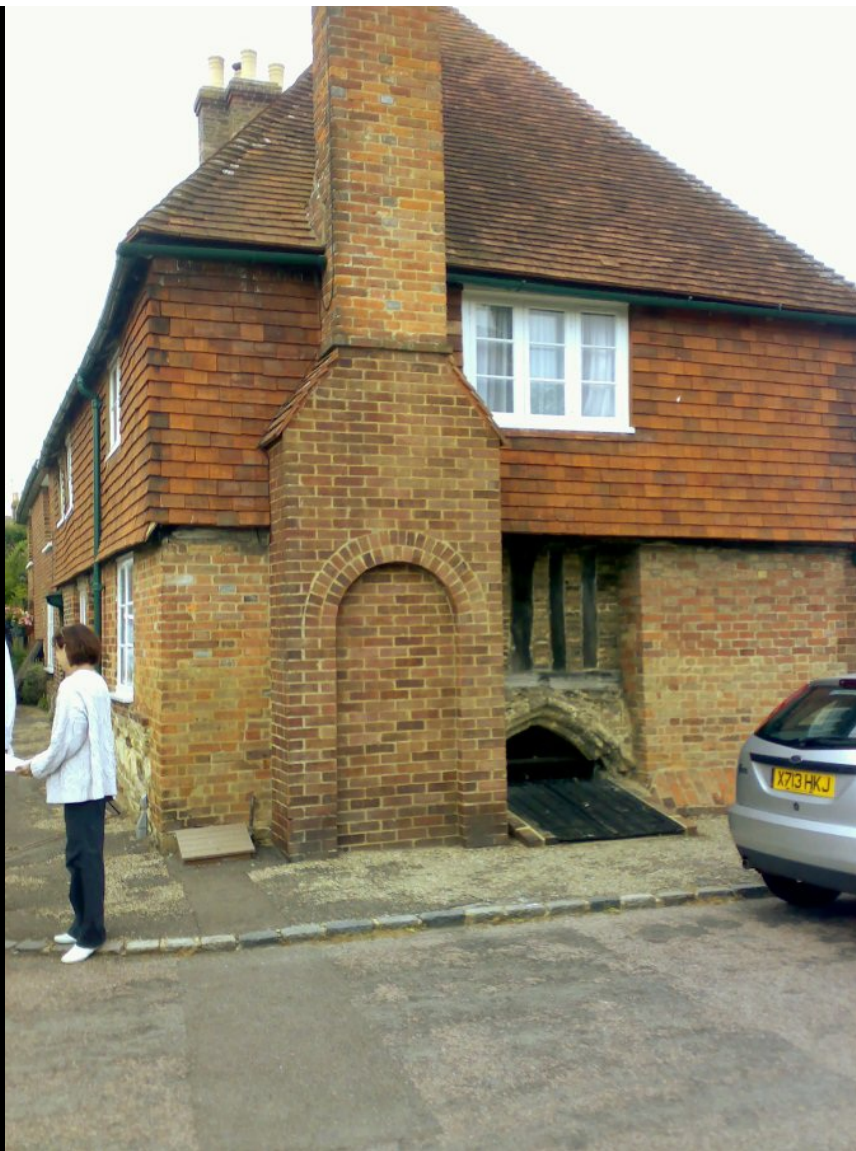
BELOW: Most of the vaults entrances had just simple barred windows at the front, with just a grille. Only one of the vaults had glazed windows and this isn't featured here... The vaults with glazed windows also appear to have been rendered inside and whitewashed, whereas those with just plain grills had no decoration inside and were far more utilitarian in feel. As can be seen from the pictures of the interiors, in most cases the walls were only roughly lined with coarse mortar.

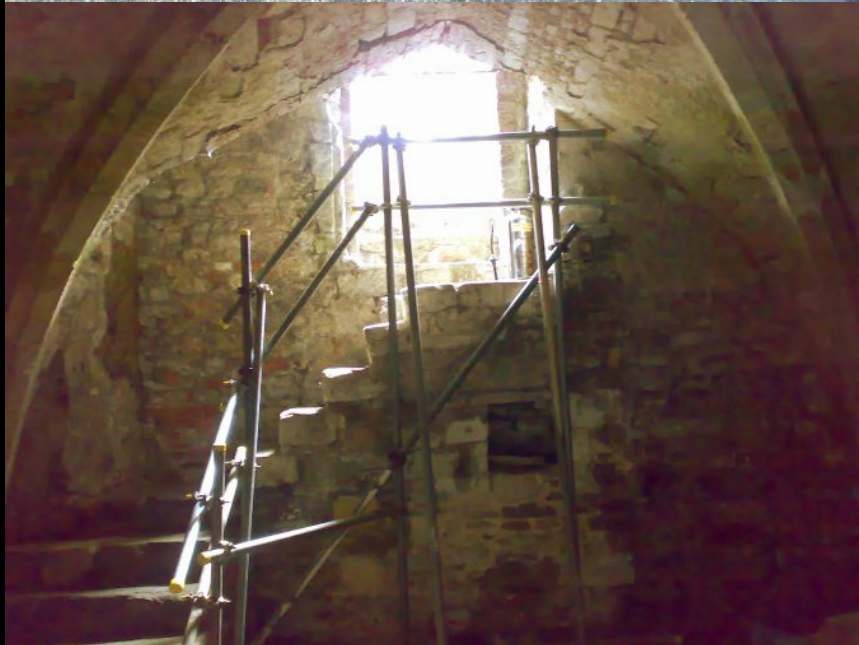
BELOW: This vault differs from the previous 2 as it has more classical (and more commonly seen) diagonal ribs, whereas the others are barrel-vaulted, ie: the ribs are purely between the sides crossing the floor area at 90 degrees.

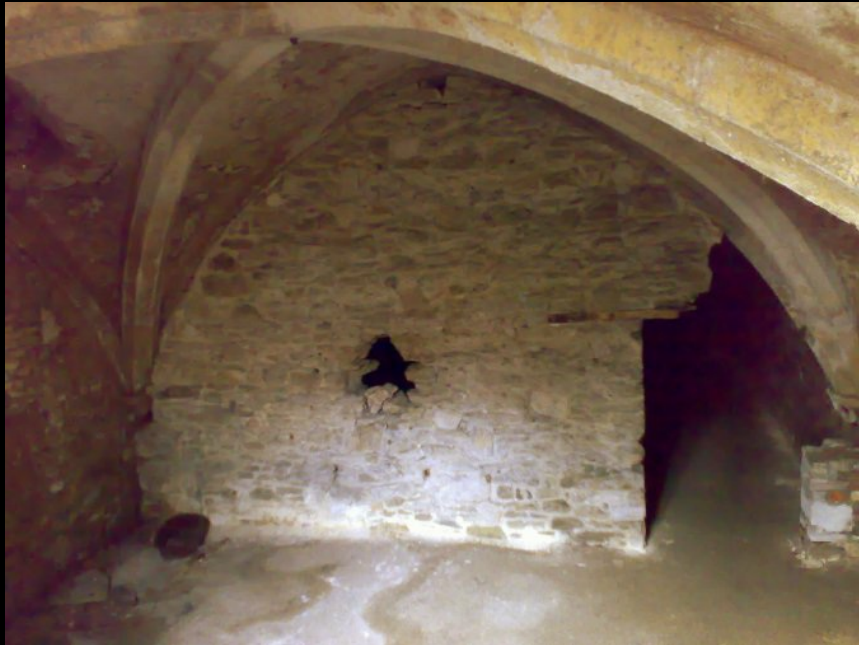
BELOW: The rough dividing wall is a later addition.

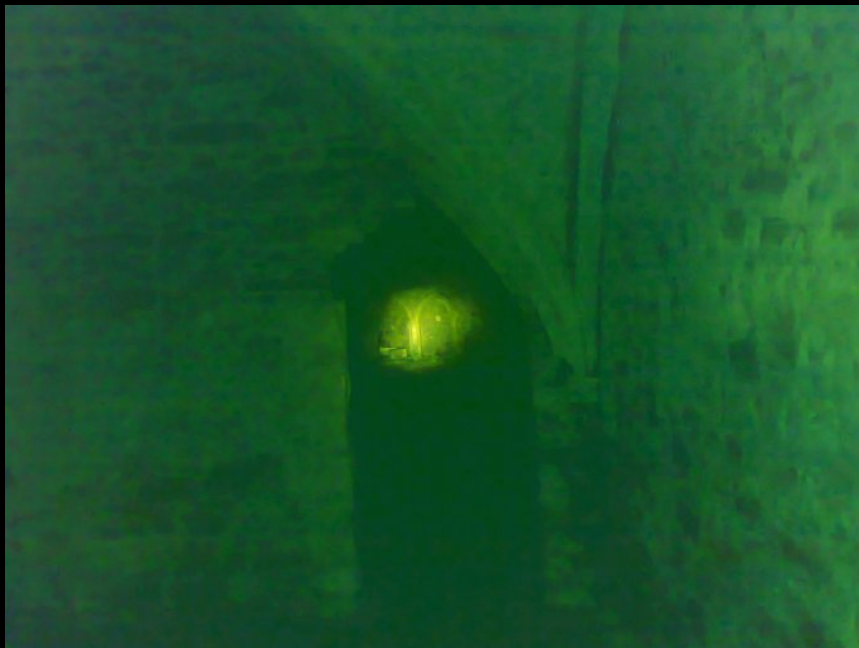
BELOW: Infrared shot of the final of the three sections of the vault. With the later addition of the two dividing walls, very little light gets to the far chamber. The 3 Aumbries are just visible in the back wall, illuminated by the spotlight's corona.
